Safety Alert

Excavator Height Restrictor

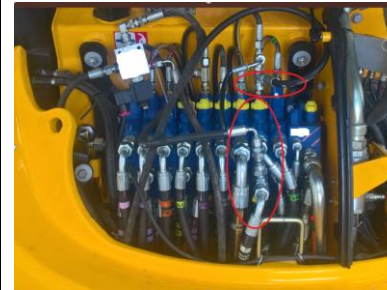
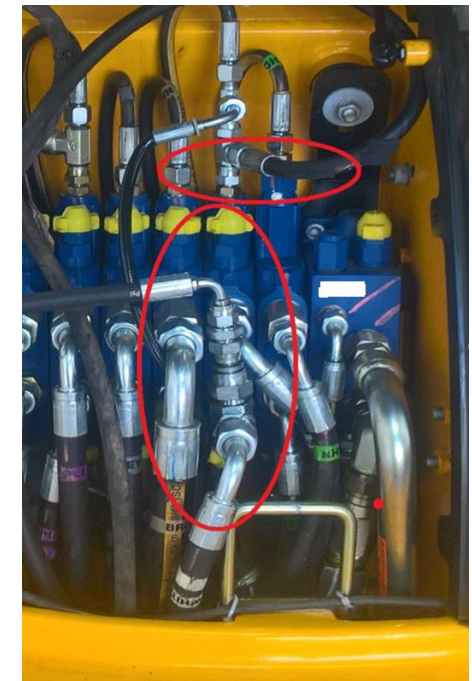
The hydraulic connections highlighted were fitted incorrectly to a 5 tonne excavator. When the height restrictor reached its set limit, oil supply was inhibited to the rams resulting in the boom dropping to the floor and bearing down which subsequently lifted the machine off the ground. This situation occurred while the machine was in a “live” electricity sub-station.

- It is essential that this height restrictor equipment is fitted by the appropriate manufacturer or using a clear set of installation instructions, with a step by step guide incorporated into workshop operating procedures.
- Products affected – excavators fitted with a temporary height restrictor

- Review existing installation procedures to ensure the use of an appropriate manufacturer, or immediate implementation of training in the safe fitting of height restrictors with an approved manufacturer.
- Immediate inspection of all current machines out on hire to ensure height restrictor is fitted according to manufacturer’s standards and to ensure installation procedures have been followed.
- Introduce verification system that will validate the height restrictor has been fitted by an approved manufacturer or by a trained and competent fitter who has undergone manufacturer’s training to ensure the correct fitting procedure has been followed and the machine is fit for purpose
